Roof Section: Section 1: 4247 E
14 Mile Building
Roof Size: 15,000 sqft

Roof Section: Section 2: 4301 E
14 Mile
Roof Size: 19,000 sqft

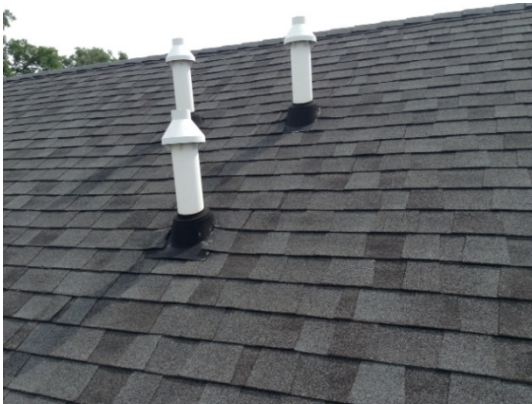
1

Damaged/Deteriorated shingle (Emergency) -
08/06/2015
Quantity: 200 SF

Deficiency: The existing roof deck is damaged/deteriorated. It appears that there was a leak issue in this area in the past and there is decking damage

Corrective Action: Remove the shingles to expose the deck. Remove and replace the deteriorated decking with matching decking. Re-shingle as necessary

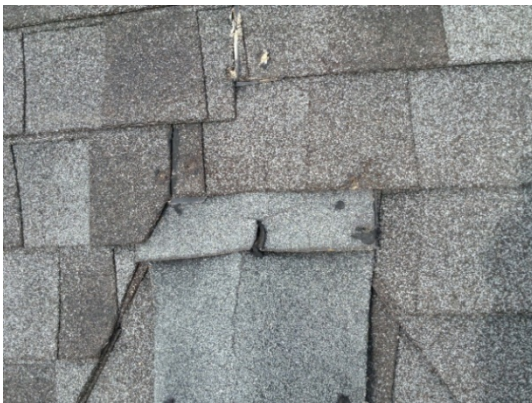
2

Damaged/Deteriorated shingle(Emergency) -
08/06/2015
Quantity: 8 EA

Deficiency: The existing shingle is damaged or has begun to deteriorate

Corrective Action: Remove faulty shingle and replace with new shingle (based on age and weathering coloring may vary)

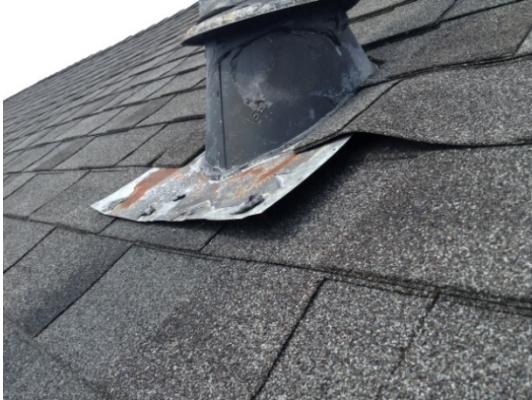
3

Failing Penetration Flashing (Remedial) -
08/06/2015
Quantity: 4 EA

Deficiency: Due to overall age, weathering or damage the flashing around the penetration has failed.

Corrective Action: Repair/flash per industry standards to ensure a water tight seal.

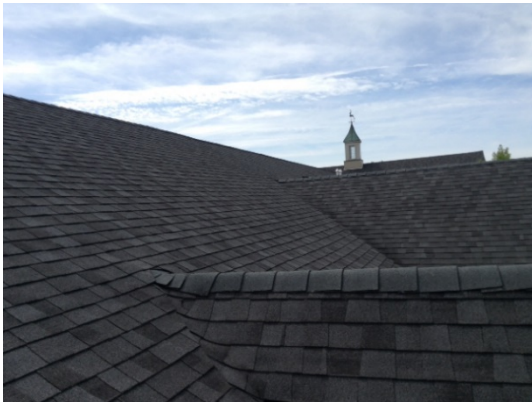
4

General Maintenance (Emergency) - 08/06/2015
Quantity: 1 LF

Deficiency: Existing roof system in need of maintenance

Corrective Action: Perform general maintenance throughout i.e. repair minor caulking , cleaning roof system, etc...

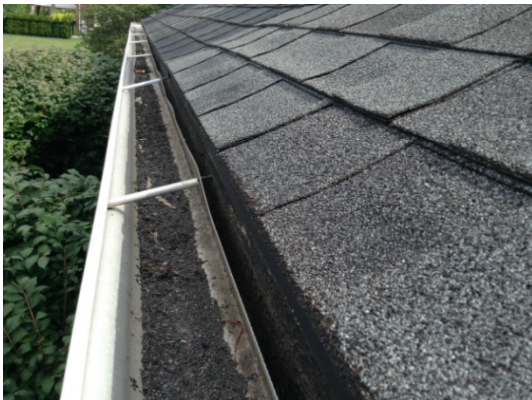
5

Missing Gutter Straps (Emergency) - 08/06/2015
Quantity: 1 EA

Deficiency: The gutter straps have either been damaged due to weather or were never installed originally.

Corrective Action: New gutter straps are to be installed per manufacturer's recommendations and details.

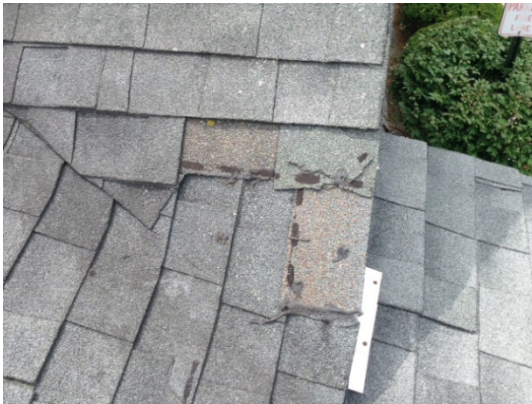
Missing Shingles/Shake (Emergency) - 08/06/2015
Quantity: 1 EA

Deficiency: There are shingles missing from the roof. This can cause the substrate to deteriorate and water to enter the structure.

Corrective Action: Install new shingles to replace missing one.

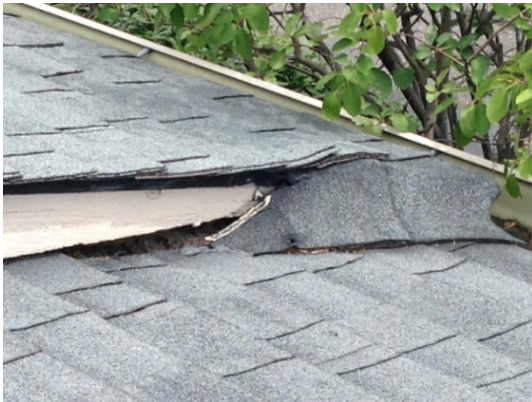
2

Improper Installation (Emergency) - 08/06/2015
Quantity: 1 EA

Deficiency: The original installation of this detail was done improperly and not per industry standards.

Corrective Action: Remove existing detail & install a new detail per the manufacturer's specifications.

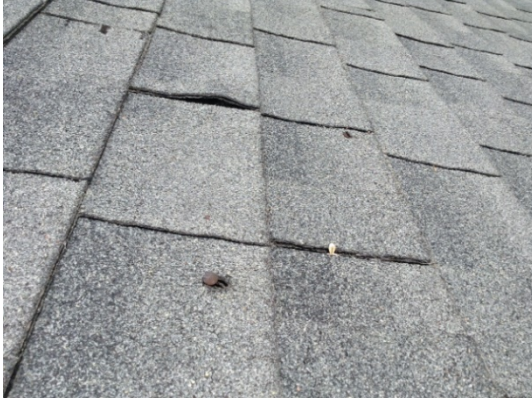
3

Nail Pops (Emergency) - 08/06/2015
Quantity: 300 EA

Deficiency: A nail pop occurs when either the nail was not installed properly or when it backs out due to building movement or weather.

Corrective Action: Reset or replace nail and apply sealant to the area.

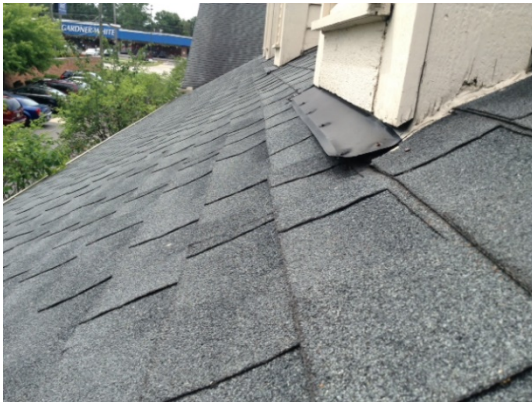
4

General Maintenance (Emergency) - 08/06/2015
Quantity: 1 EA

Deficiency: General maintenance is required on all roof system to insure proper working order and to help prevent future issues

Corrective Action: Clean roof free of debris, check through roof penetrations and make sure they are properly sealed, make sure roof drains are clear for proper water flow, etc...

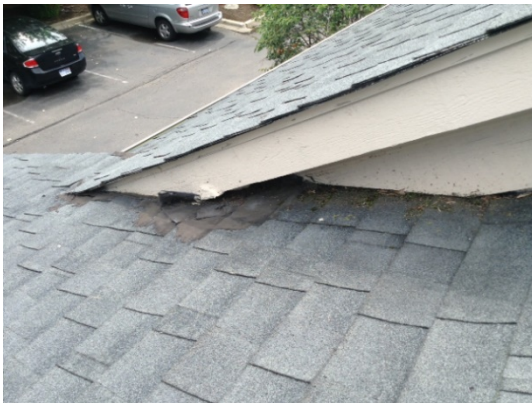
5

Improper Installation (Emergency) - 08/06/2015
Quantity: 1 EA

Deficiency: The original installation of this detail was done improperly and not per industry standards.

Corrective Action: Remove existing detail & install a new detail per the manufacturer's specifications.

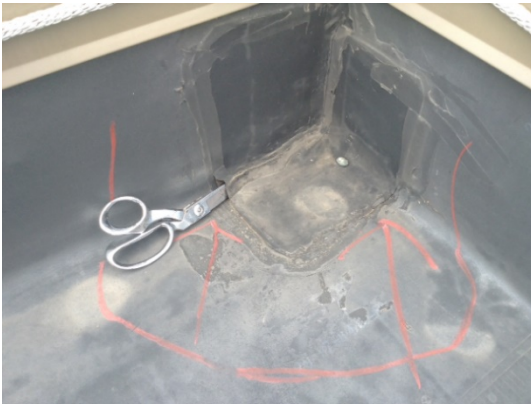
Open Flashing(Emergency) - 07/22/2015
Quantity: 1 EA

Deficiency: Open flashing can be caused by membrane shrinkage, insufficient counterflashing or aging of the original flashing.

Corrective Action: The flashing will either be removed & new flashing installed, or re-seal the existing flashing.

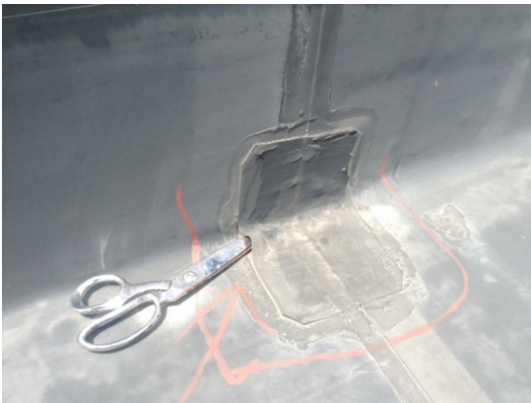
2

Open Vertical Flashing Seam(Remedial) -
07/22/2015
Quantity: 7 LF

Deficiency: The existing vertical flashing seam is open

Corrective Action: Clean the seam as necessary and install new roof cement and membrane as necessary or new single ply membrane as necessary

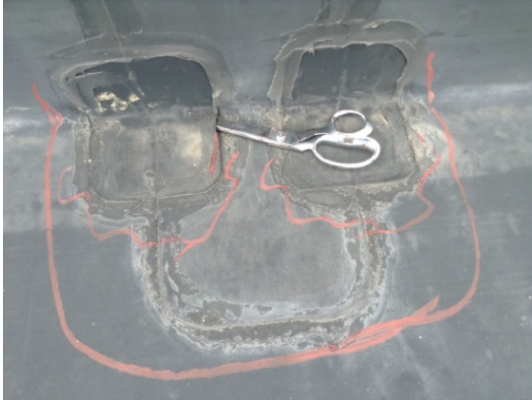
3

Open Flashing(Emergency) - 07/22/2015
Quantity: 1 EA

Deficiency: Open flashing can be caused by membrane shrinkage, insufficient counterflashing or aging of the original flashing.

Corrective Action: The flashing will either be removed & new flashing installed, or re-seal the existing flashing.

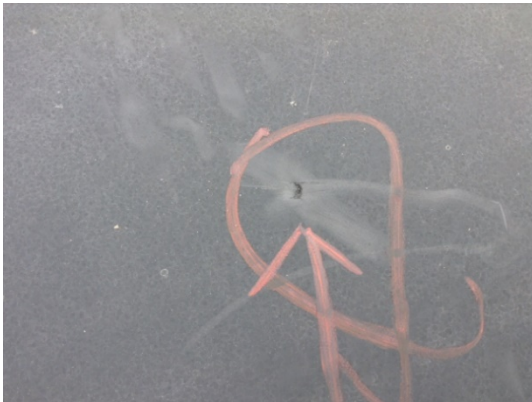
4

Punctures - Rips - Tears(Emergency) - 07/22/2015
Quantity: 1 EA

Deficiency: Typically caused by foot traffic, mechanical work, or simply because the membrane is at the end of it's service life.

Corrective Action: Clean the roof area, install a new piece of membrane and seal.

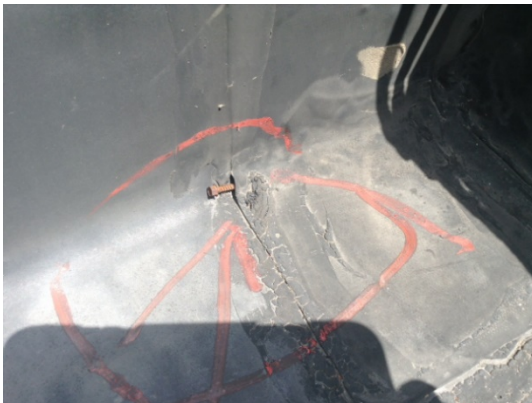
5

Open Flashing(Emergency) - 07/22/2015
Quantity: 2 EA

Deficiency: Open flashing can be caused by membrane shrinkage, insufficient counterflashing or aging of the original flashing.

Corrective Action: The flashing will either be removed & new flashing installed, or re-seal the existing flashing.

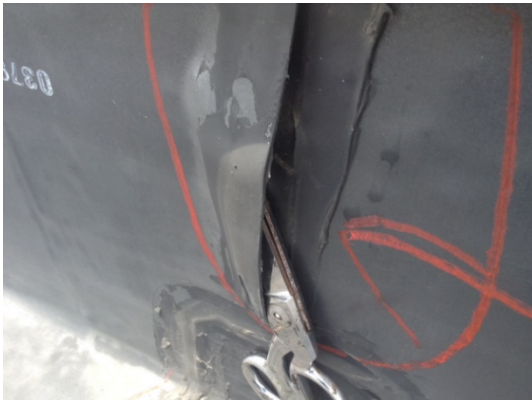
6

Open Vertical Flashing Seam(Emergency) -
07/22/2015
Quantity: 1 LF

Deficiency: The existing vertical flashing seam is open

Corrective Action: Clean the seam as necessary and install new roof cement and membrane as necessary or new single ply membrane as necessary

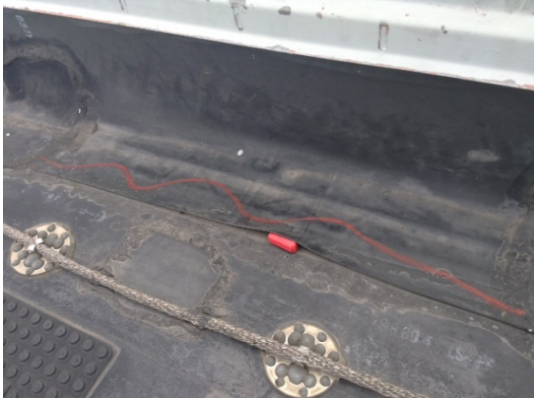
7

Open Flashing(Emergency) - 07/22/2015
Quantity: 18 LF

Deficiency: Open flashing can be caused by membrane shrinkage, insufficient counterflashing or aging of the original flashing.

Corrective Action: The flashing will either be removed & new flashing installed, or re-seal the existing flashing.

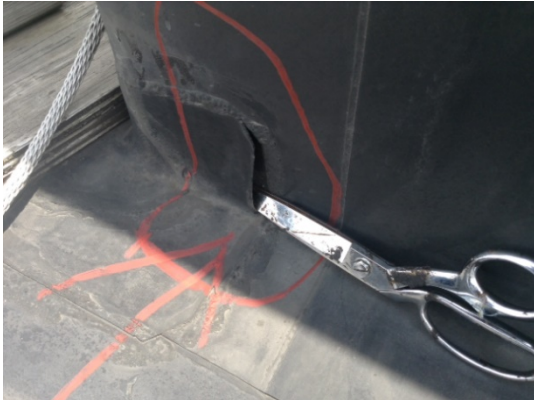
8

Open Curb Corner(Emergency) - 07/22/2015
Quantity: 18 EA

Deficiency: The corner flashing on the roof curb is split or has an open seam.

Corrective Action: Remove the old membrane and install new corner flashing.

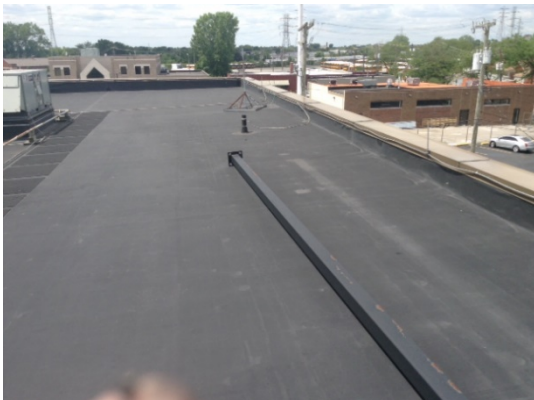
9

Loose Debris(Remedial) - 07/22/2015
Quantity: 1 EA

Deficiency: Loose debris has a high probability of blowing around on the roof and causing damage to the waterproofing membrane or can blow off a building possible injuring someone.

Corrective Action: Remove loose debris from roof area.

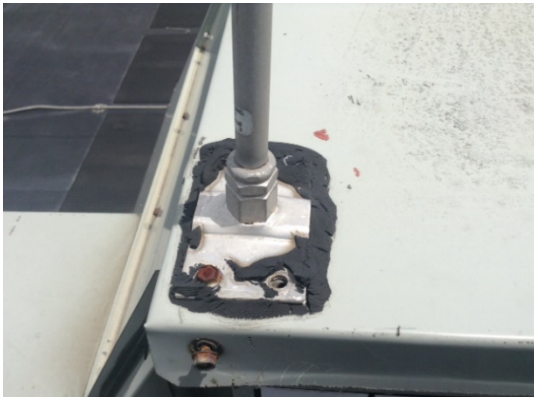
10

Open Sealant(Remedial) - 07/22/2015
Quantity: 20 EA

Deficiency: Openings found in existing sealant.

Corrective Action: Remove loose sealant and apply new sealant.

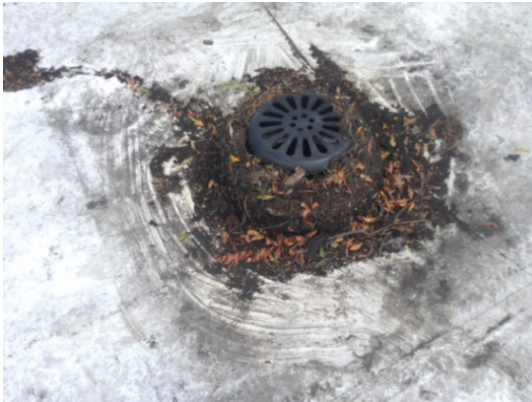
Clogged Scupper/Drain/Gutter(Emergency) -
07/31/2015
Quantity: 1 EA

Deficiency: The existing scupper, drain, or gutter has become clogged and is no longer functioning properly.

Corrective Action: Remove all debris from the scupper, drain, or gutter area to ensure that water properly drains from the roof.

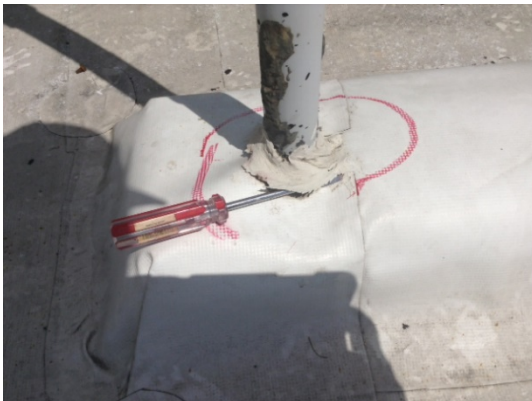
Failing Penetration Flashing(Emergency) -
07/31/2015
Quantity: 2 EA

Deficiency: Due to overall age, weathering or damage the flashing around the penetration has failed.

Corrective Action: Repair/flash per industry standards to ensure a water tight seal.

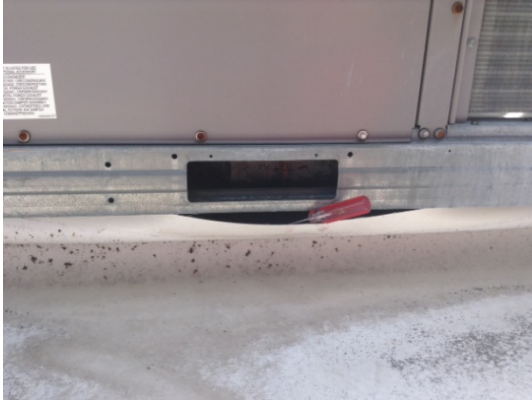
3

Metal Counter/Slip Flashing Missing(Emergency) - 07/31/2015
Quantity: 60 LF

Deficiency: The top of the metal or membrane needs a metal flashing installed to keep water out of the structure.

Corrective Action: Fabricate and install new metal flashing per industry standards to create a watertight seal.

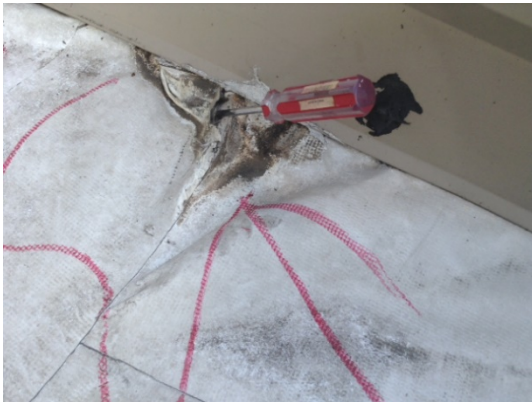
4

Previous Repair Failure(Emergency) - 07/31/2015
Quantity: 1 EA

Deficiency: Existing repair failing due to age or improper repair.

Corrective Action: Remove the existing repair, clean & prime the area and install new membrane.

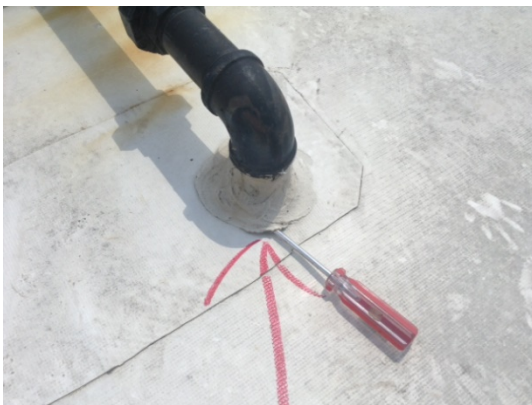
5

Failing Penetration Flashing(Emergency) - 07/31/2015
Quantity: 1 EA

Deficiency: Due to overall age, weathering or damage the flashing around the penetration has failed.

Corrective Action: Repair/flash per industry standards to ensure a water tight seal.

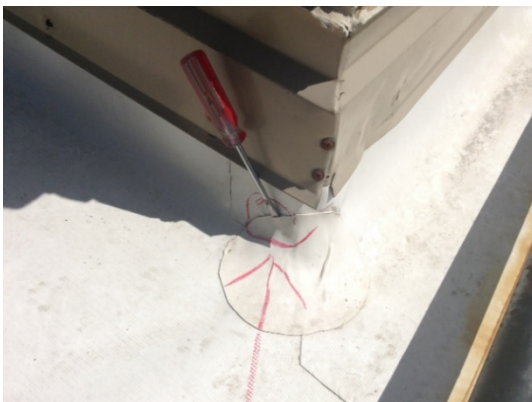
6

Open Curb Corner(Emergency) - 07/31/2015
Quantity: 3 EA

Deficiency: The corner flashing on the roof curb is split or has an open seam.

Corrective Action: Remove the old membrane and install new corner flashing.

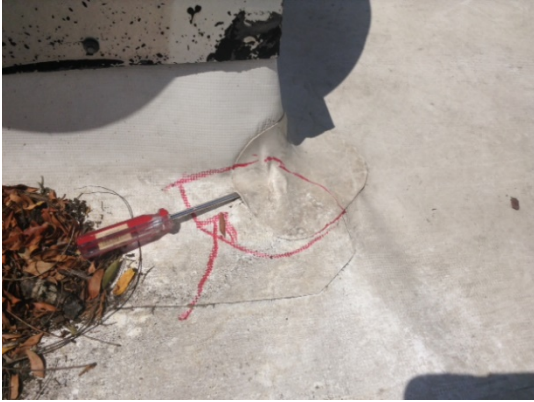
7

Open Curb Corner(Emergency) - 07/31/2015
Quantity: 1 EA

Deficiency: The corner flashing on the roof curb is split or has an open seam.

Corrective Action: Remove the old membrane and install new corner flashing.

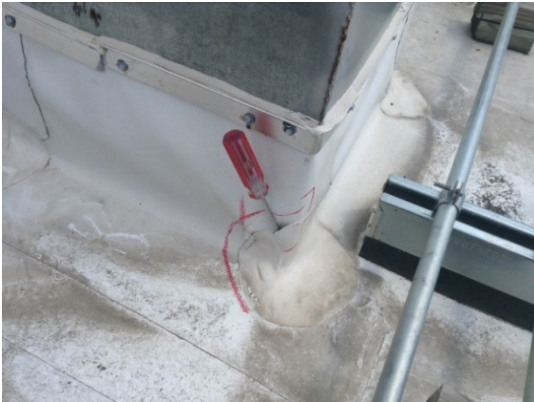
1

Open Curb Corner(Emergency) - 07/31/2015
Quantity: 4 EA

Deficiency: The corner flashing on the roof curb is split or has an open seam.

Corrective Action: Remove the old membrane and install new corner flashing.

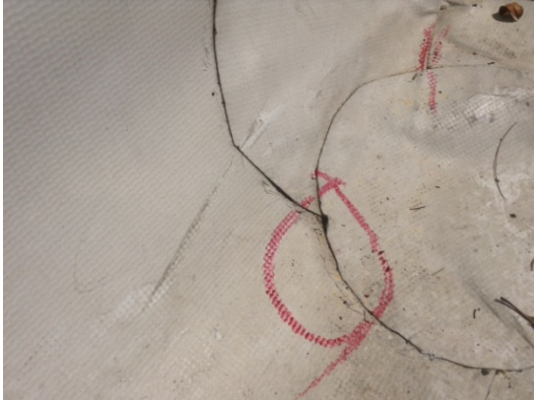
2

Open Flashing(Remedial) - 07/31/2015
Quantity: 1 EA

Deficiency: Open flashing can be caused by membrane shrinkage, insufficient counterflashing or aging of the original flashing.Q

Corrective Action: The flashing will either be removed & new flashing installed, or re-seal the existing flashing.

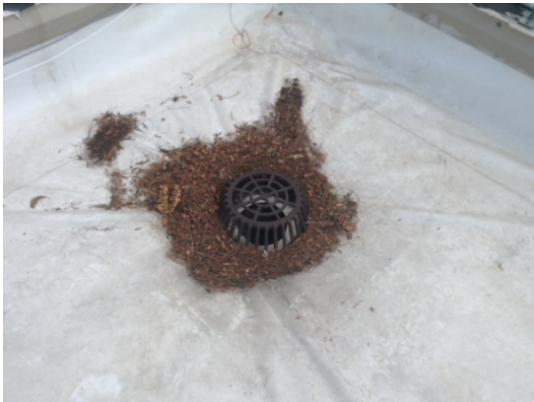
3

Clogged Scupper/Drain/Gutter(Emergency) - 07/31/2015
Quantity: 2 EA

Deficiency: The existing scupper, drain, or gutter has become clogged and is no longer functioning properly.

Corrective Action: Remove all debris from the scupper, drain, or gutter area to ensure that water properly drains from the roof.

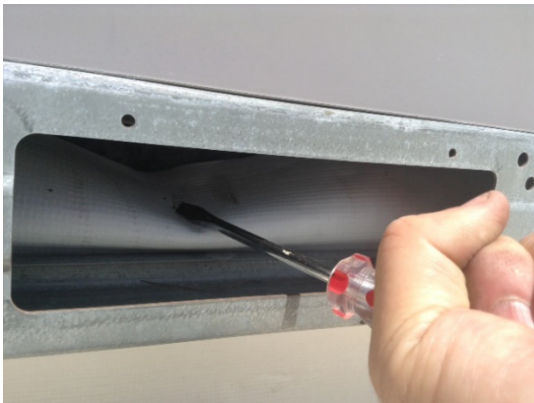
4

Metal Counter/Slip Flashing Missing(Emergency) - 07/31/2015
Quantity: 60 EA

Deficiency: The top of the metal or membrane needs a metal flashing installed to keep water out of the structure.

Corrective Action: Fabricate and install new metal flashing per industry standards to create a watertight seal.

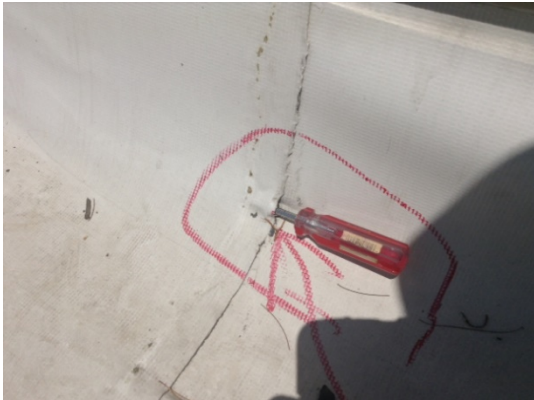
5

Open Vertical Flashing Seam(Emergency) - 07/31/2015
Quantity: 1 LF

Deficiency: The existing vertical flashing seam is open

Corrective Action: Clean the seam as necessary and install new roof cement and membrane as necessary or new single ply membrane as necessary

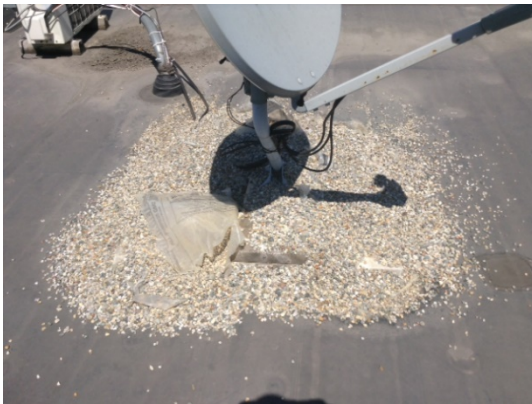
No Roof Protection(Emergency) - 07/31/2015
Quantity: 1 EA

Deficiency: There is no protection mat under the supports/blocking to protect the roof surface from punctures.

Corrective Action: Check for holes under the support and repair any deficiencies. Insert approved walkway pad under the support to prevent holes.

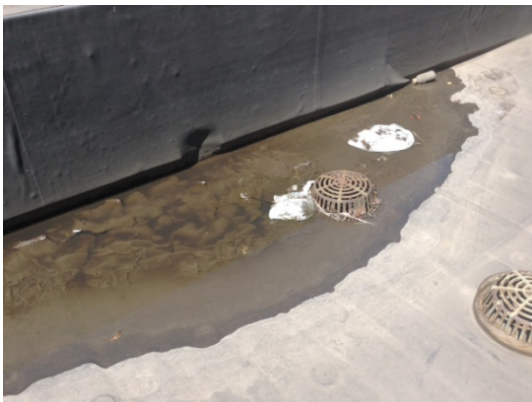
2

Clogged Scupper/Drain/Gutter(Emergency) - 07/31/2015
Quantity: 1 EA

Deficiency: The existing scupper, drain, or gutter has become clogged and is no longer functioning properly.

Corrective Action: Remove all debris from the scupper, drain, or gutter area to ensure that water properly drains from the roof.

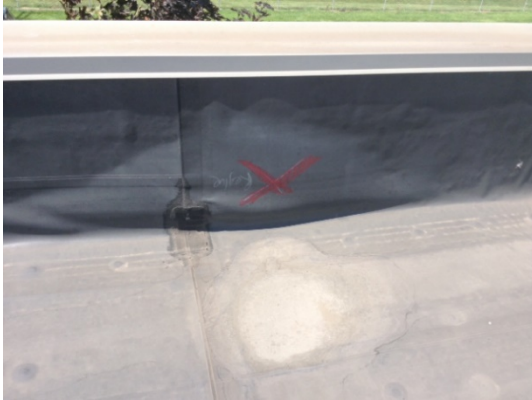
3

Bridged/Loose Base Flashing(Emergency) -
07/31/2015
Quantity: 50 LF

Deficiency: Bridging of the membrane is caused by the overall shrinking that takes place over time causing the membrane to pull away from perimeter walls.

Corrective Action: Cut the existing membrane and install a new piece of flashing.

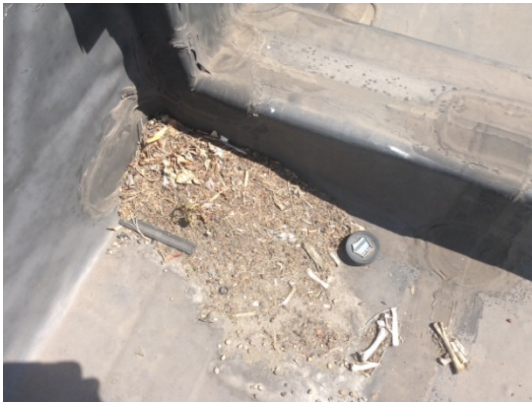
4

Loose Debris(Remedial) - 07/31/2015
Quantity: 1 EA

Deficiency: Loose debris has a high probability of blowing around on the roof and causing damage to the waterproofing membrane or can blow off a building possible injuring someone.

Corrective Action: Remove loose debris from the entire roof area.

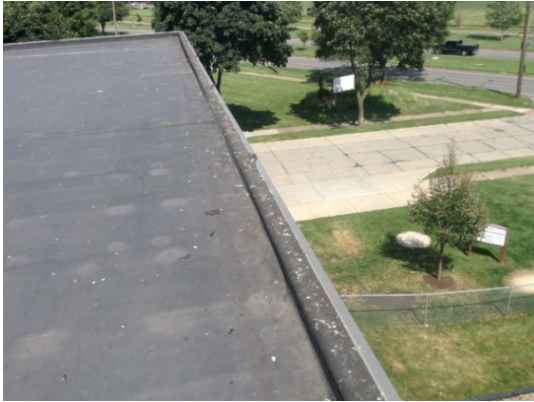
1

Pigeons(Remedial) - 07/31/2015
Quantity: 400 LF

Deficiency: Pigeons are perching on the perimeter walls and defecating. This can damage the detail membrane

Corrective Action: Install a pigeon deterrent system as necessary

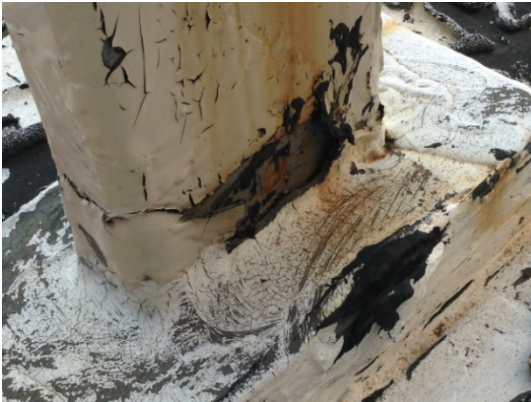
1

Penetration Pocket Open(Emergency) - 09/01/2015
Quantity: 7 EA

Deficiency: Sealant used to fill penetration pocket has settled or is separated along the edges.

Corrective Action: Install new sealant to make penetration pocket watertight.

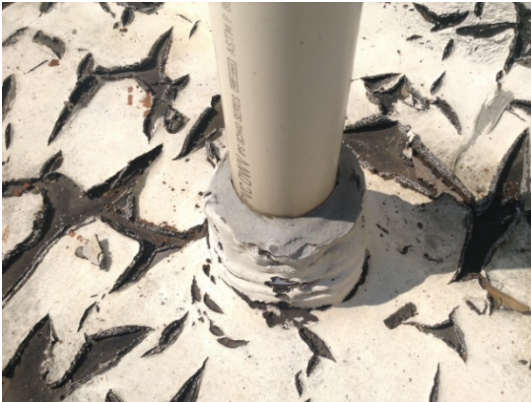
2

Open Sealant(Emergency) - 09/01/2015
Quantity: 3 EA

Deficiency: Openings found in existing sealant.

Corrective Action: Remove loose sealant and apply new sealant.

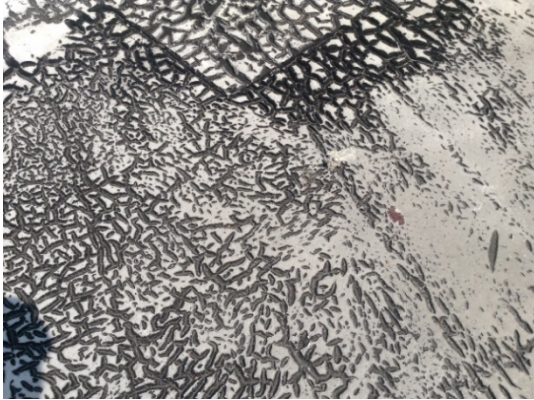
3

Alligating(Remedial) - 09/01/2015
Quantity: 1500 SF

Deficiency: Alligating is a result of the waterproofing membrane drying out due to UV exposure. This condition can lead to direct water infiltration through the membrane.

Corrective Action: Clean & prep the area; install an additional layer of membrane or a coating over the area of membrane ensuring a water tight condition.

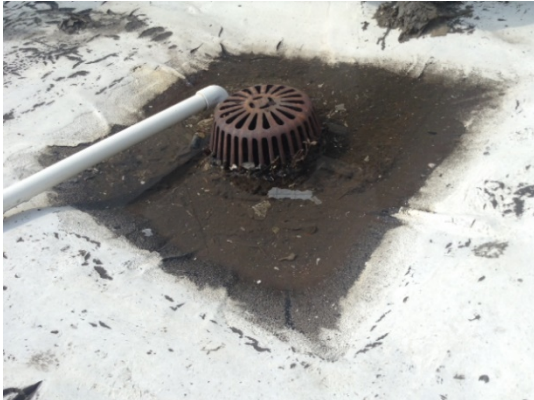
4

Clogged Scupper/Drain/Gutter(Emergency) - 09/01/2015
Quantity: 1 EA

Deficiency: The existing scupper, drain, or gutter has become clogged and is no longer functioning properly.

Corrective Action: Remove all debris from the scupper, drain, or gutter area to ensure that water properly drains from the roof.

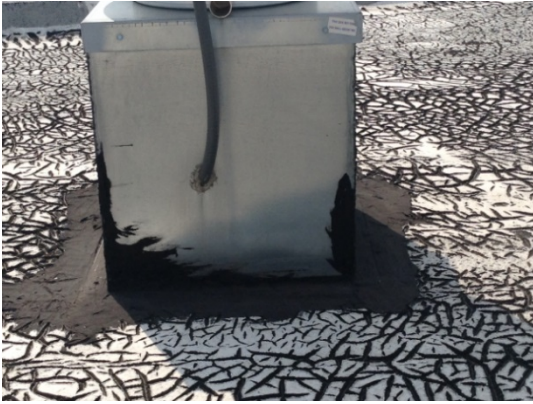
Failing Penetration Flashing(Emergency) -
09/01/2015
Quantity: 1 EA

Deficiency: Due to overall age, weathering or damage the flashing around the penetration has failed.

Corrective Action: Repair/flash per industry standards to ensure a water tight seal.

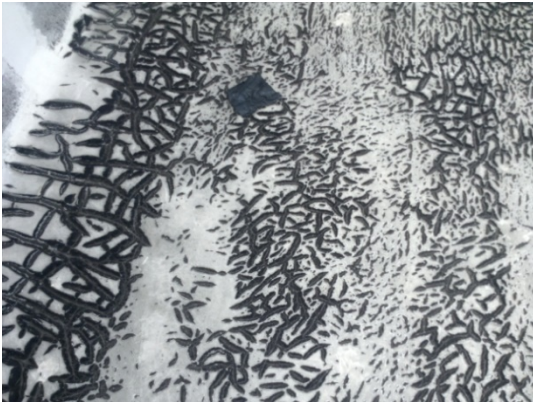
2

Alligating(Remedial) - 09/01/2015
Quantity: 3000 SF

Deficiency: Alligating is a result of the waterproofing membrane drying out due to UV exposure. This condition can lead to direct water infiltration through the membrane.

Corrective Action: Clean & prep the area; install an additional layer of membrane or a coating over the area of membrane ensuring a water tight condition.

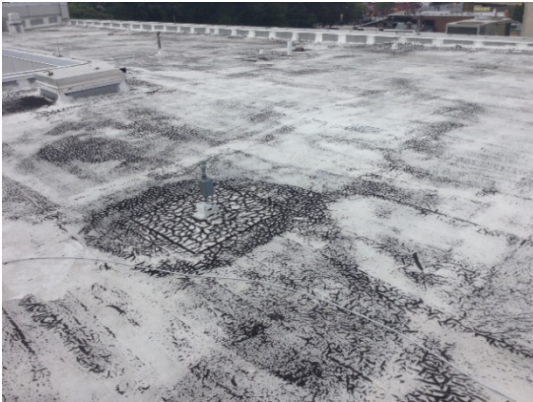
3

General Maintenance(Remedial) - 09/01/2015
Quantity: 1 EA

Deficiency: General maintenance is required on all roof system to insure proper working order and to help prevent future issues

Corrective Action: Clean roof free of debris, check through roof penetrations and make sure they are properly sealed, make sure roof drains are clear for proper water flow, etc...

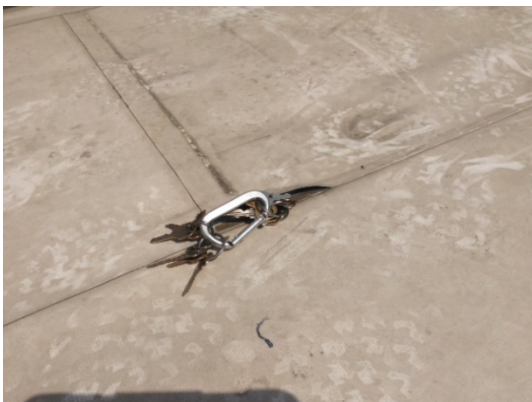
Open Field Seams(Emergency) - 09/01/2015
Quantity: 1 EA

Deficiency: Open membrane seams are typically caused by failing seam adhesives coupled with membrane shrinkage & stress on the seams.

Corrective Action: Clean & prep the area and install a new piece of membrane.

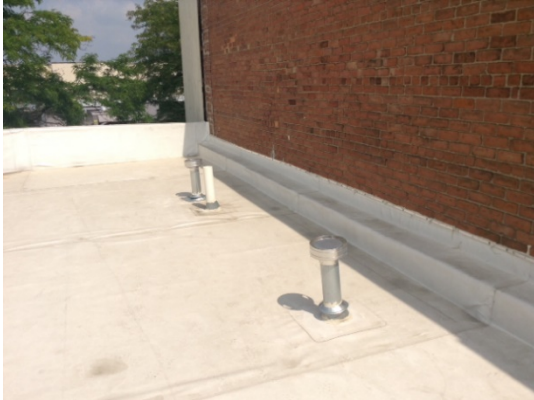
2

Failing Penetration Flashing(Emergency) - 09/01/2015
Quantity: 3 EA

Deficiency: Due to overall age, weathering or damage the flashing around the penetration has failed.

Corrective Action: Repair/flash per industry standards to ensure a water tight seal.

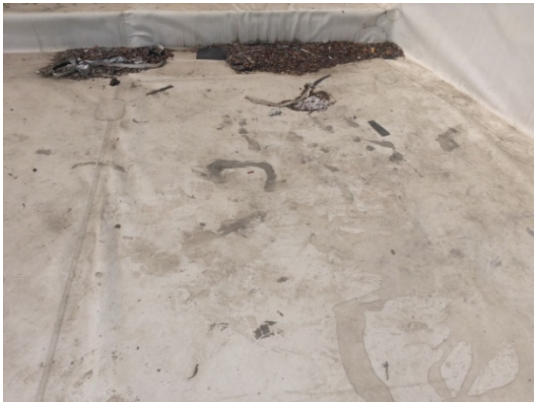
3

General Maintenance(Emergency) - 09/01/2015
Quantity: 1 EA

Deficiency: General maintenance is required on all roof system to insure proper working order and to help prevent future issues

Corrective Action: Clean roof free of debris, check through roof penetrations and make sure they are properly sealed, make sure roof drains are clear for proper water flow, etc...

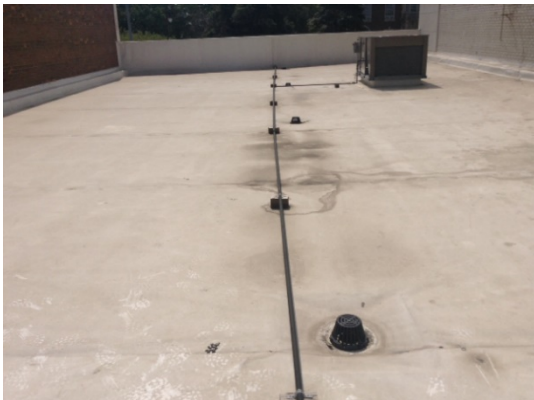
4

No Roof Protection(Remedial) - 09/01/2015
Quantity: 10 EA

Deficiency: There is no protection mat under the supports/blocking to protect the roof surface from punctures.

Corrective Action: Check for holes under the support and repair any deficiencies. Insert approved walkway pad under the support to prevent holes.

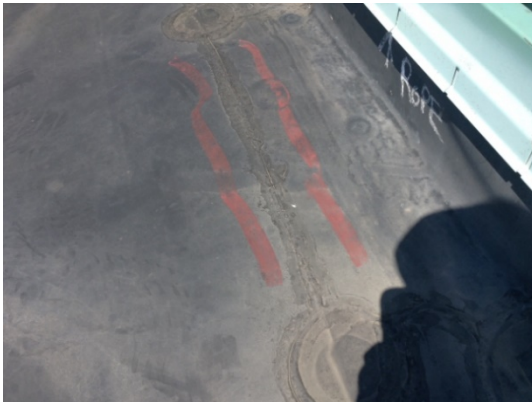
1

Open Field Seams(Emergency) - 07/23/2015
Quantity: 16 LF

Deficiency: Open membrane seams are typically caused by failing seam adhesives coupled with membrane shrinkage & stress on the seams.

Corrective Action: Clean & prep the area and install a new piece of membrane.

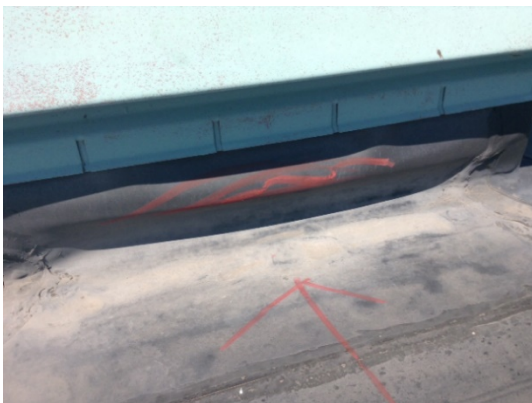
2

Bridged/Loose Base Flashing(Emergency) -
07/23/2015
Quantity: 16 LF

Deficiency: In this case the loose base flashing is due to no backer Rod

Corrective Action: Install Backer Rod per manufacturer specification

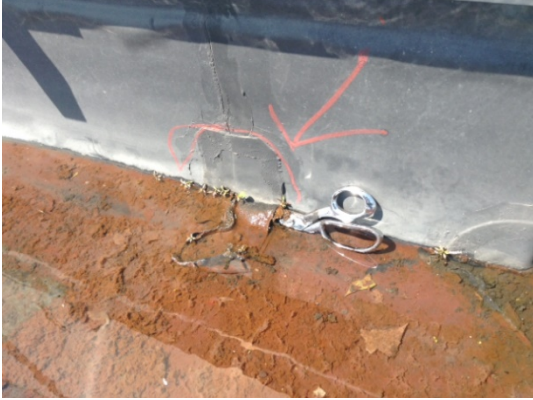
3

Open Flashing(Emergency) - 07/23/2015
Quantity: 1 EA

Deficiency: Open flashing can be caused by membrane shrinkage, insufficient counterflashing or aging of the original flashing.

Corrective Action: The flashing will either be removed & new flashing installed, or re-seal the existing flashing.

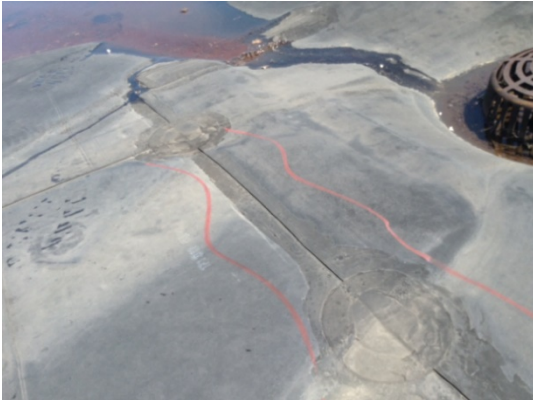
4

Open Field Seams(Emergency) - 07/23/2015
Quantity: 20 LF

Deficiency: Open membrane seams are typically caused by failing seam adhesives coupled with membrane shrinkage & stress on the seams.

Corrective Action: Clean & prep the area and install a new piece of membrane.

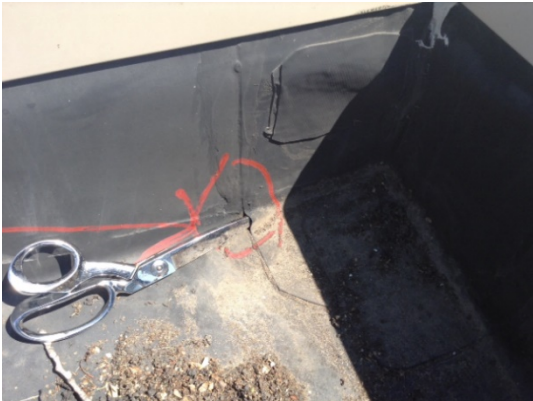
5

Open Flashing(Emergency) - 07/23/2015
Quantity: 1 EA

Deficiency: Open flashing can be caused by membrane shrinkage, insufficient counterflashing or aging of the original flashing.

Corrective Action: The flashing will either be removed & new flashing installed, or re-seal the existing flashing.

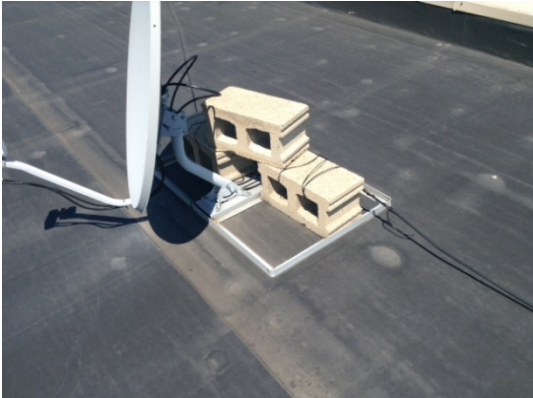
6

No Roof Protection(Remedial) - 07/23/2015
Quantity: 1 EA

Deficiency: There is no protection mat under the supports/blocking to protect the roof surface from punctures.

Corrective Action: Check for holes under the support and repair any deficiencies. Insert approved walkway pad under the support to prevent holes.
